**Inspection Report**

**Minerals Regulatory Program**

**Mine Name:** Milla' Martinique  
**Operator Name:** Martinique Mining

**Permit number:** S0170046  
**Inspection Date:** May 12, 2008  
**Time:** 1:00-1:20 PM

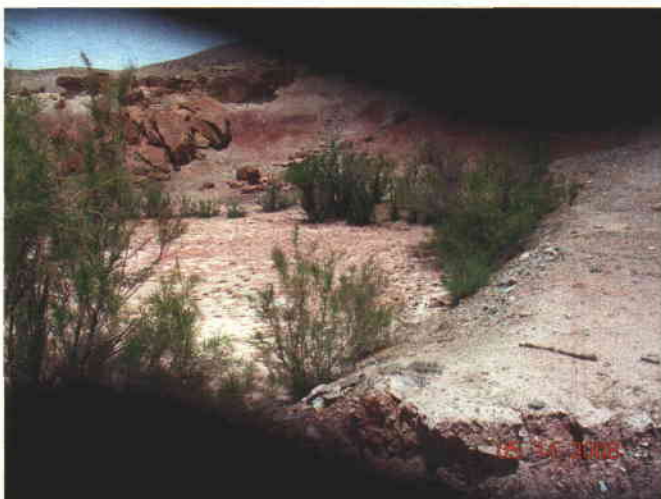
On the north side of the site is a series of small impoundments, and the dams have breached (Photo 1). (Unfortunately my lens cover did not fully open, and I was not aware of this until getting the pictures off the camera.) Vegetation around these ponds is mostly greasewood. On the southeast side is a larger impoundment with a lot of tamarisk around the edges (Photo 2), but as far as I can determine, this pond is not part of the operator's responsibility (see discussion under conclusions and recommendations below).

Photo 1. This is a small pond on the north side of the site where the dam has breached.

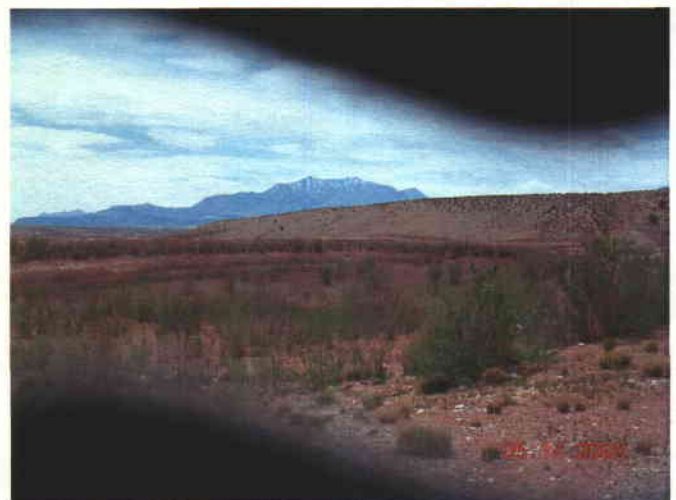
According to the NOI, tailings would be stored in a small pond and cleaned up and stacked for testing. This small pond is not the same as the larger pond, and I was unable to see any sign of the smaller pond. Buzz Rakow of the BLM said the BLM has not considered the pond as part of Milla' Martinique.

Photo 2. This pond is adjacent to the mill site but is not part of the operator's responsibility.

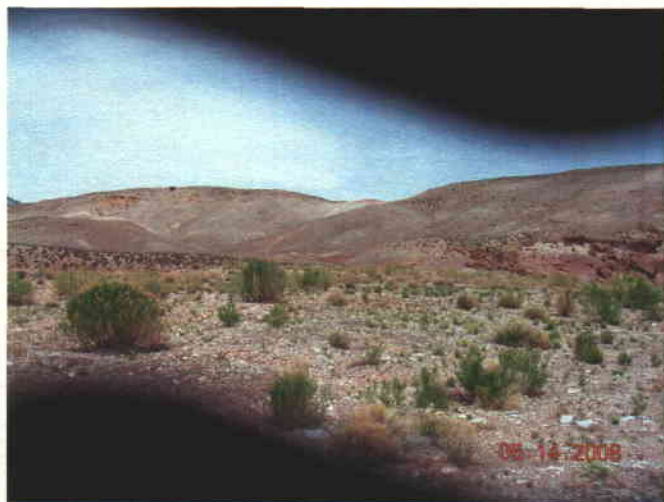
Vegetation in the reclaimed area also varies widely, but in this case it is more because of the degree of compaction of working areas. I estimated cover to be 14.7 percent. Most of the vegetation is rabbitbrush, and there are a lot of rabbitbrush seedlings.

**Photo 3.** This picture and Photos 4 through 6 show the reclaimed area and some of the adjacent undisturbed areas.
